**Subject: Draft Trip Report for the Riverside Avenue Site
Riverside Avenue, Newark, Essex County, New Jersey
EPA Contract No. EP-S7-06-01
TDD No. 0178
Document Tracking No. 1018**

Tetra Tech EM Inc. (Tetra Tech) is submitting the draft trip report for the Riverside Avenue Site located at 29-47 Riverside Avenue in Newark, New Jersey. The trip report summarizes the sampling activities conducted at the site between June 7 and 17, 2010. If you have any questions regarding the draft report, please contact me at (610) 364-2119.

**DRAFT TRIP REPORT
RIVERSIDE AVENUE SITE
NEWARK, NJ**

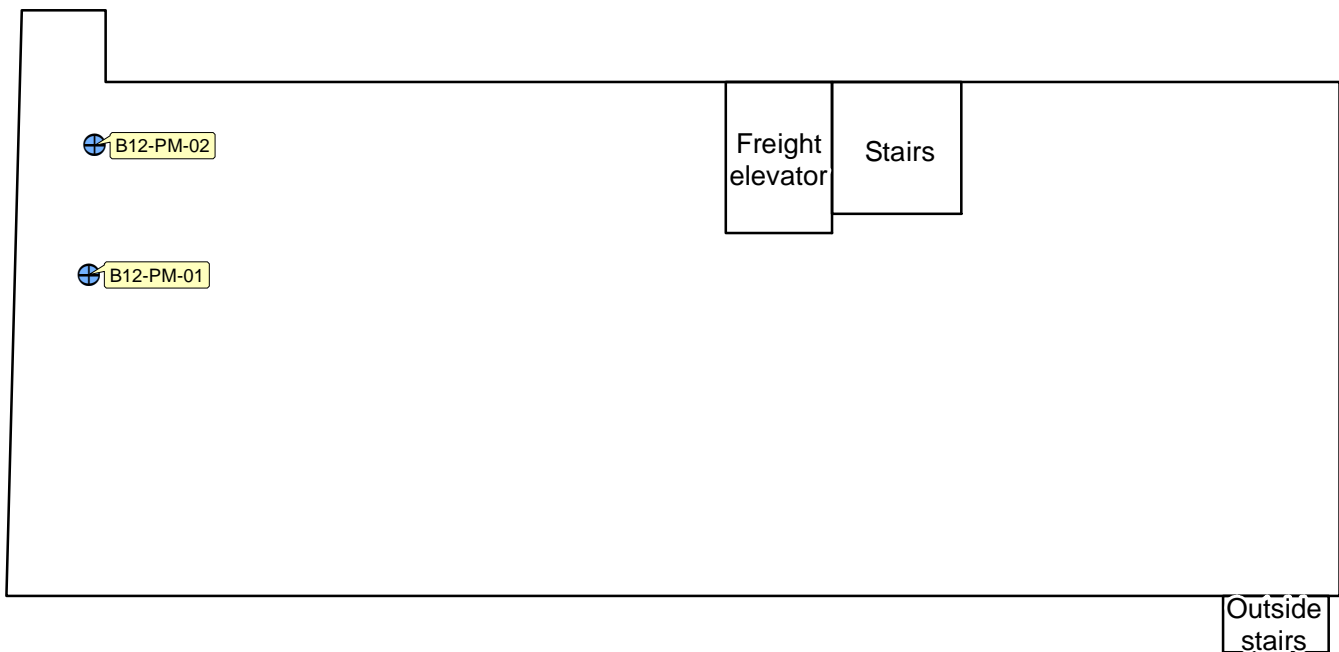
Tetra Tech collected one sample of the red-colored pigment and one sample of blue-colored pigments observed on the floors of Building #12. Figure 8 shows the locations of the pigment samples collected from Building #12. At each sampling location, Tetra Tech filled one certified-clean, 4-ounce CWM glass jar with Teflon lined septa lids for TCL VOC and three certified-clean 8-ounce CWM glass jars for TCL SVOCs, pesticides and PCBs. At each sampling location, Tetra Tech filled one certified-clean, 4-ounce CWM glass jars with Teflon lined septa lids for TCL VOCs and three certified-clean 8-ounce CWM glass jars with Teflon lined lids for TCL SVOCs, pesticides, Aroclors, TAL Total metals and cyanide, and ignitibility and corrosivity analyses.

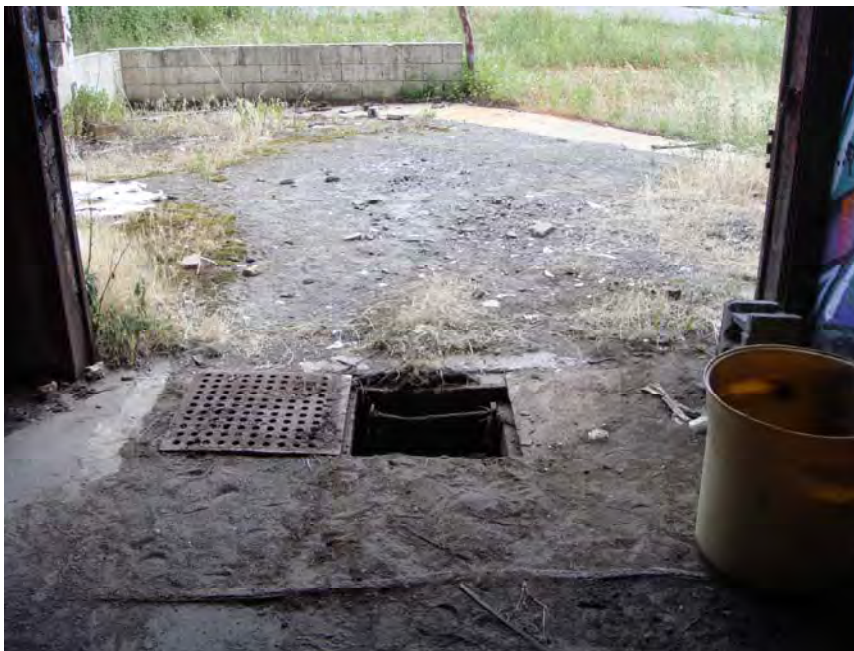
Photograph No. 16

Description: View of manhole leading into subbasement of Building #7 (garage bay, south west side). Also location of samples B7-BW-01, B7-BW-03. B7-SED-02 and BW-SED-03.

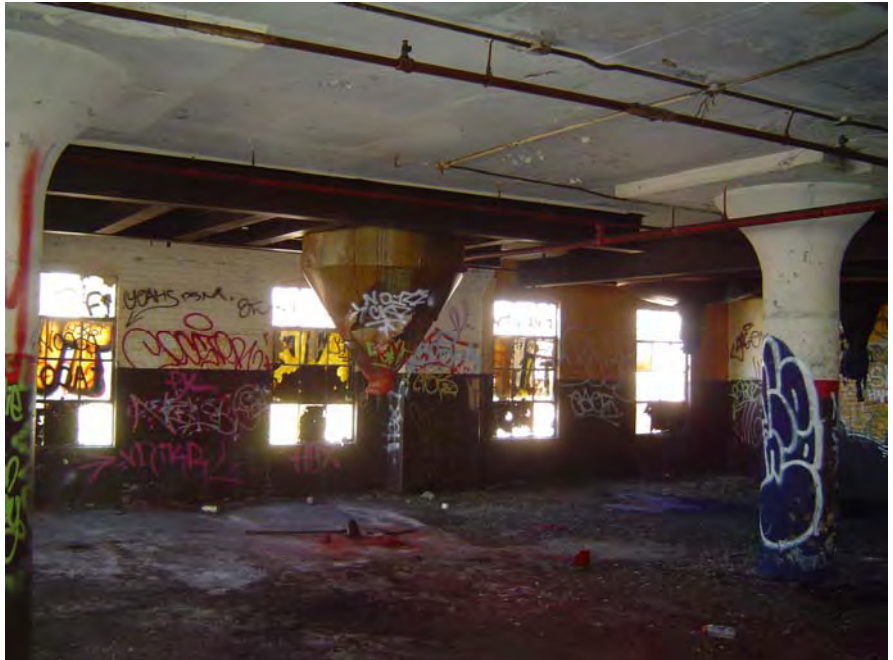
Tetra Tech collected samples of the red and blue-colored pigments observed on the floors of Building #12. Approximately ½ inch of dry pigment material had accumulated immediately beneath the openings of two funnel tanks that protruded from the ceiling of the fourth floor of Building #12. The samples were collected using dedicated, disposal plastic scoops. Pigment material was scraped into a pile with the plastic scoop and then scooped and transferred directly into the appropriate sample containers. The pigment material was mixed with debris and what appeared to be bird droppings and a pure sample of the pigment material could not be obtained. Nearly all of the blue and red pigment that was present was placed into sample containers and only residue remained at the site after sample collection.

Description: View of colored pigment material on fourth floor of Building #12. Also location of samples B12-PM-01 and B12-PM-02.
